**TAYANA 37**

Newsletter No. 7
1348 Nonchalant Drive
Simi Valley, California 93065

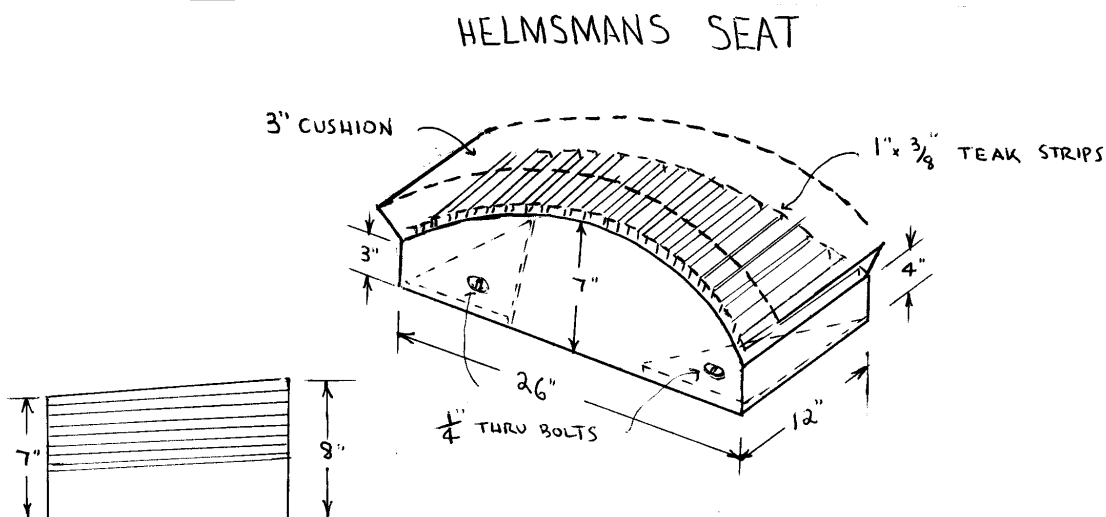
Rolf has made a helmsman seat which allows him to sit high on either tack and to see well while motoring (see sketch). The cushion is kept on the seat with straps. The back is open for storage.

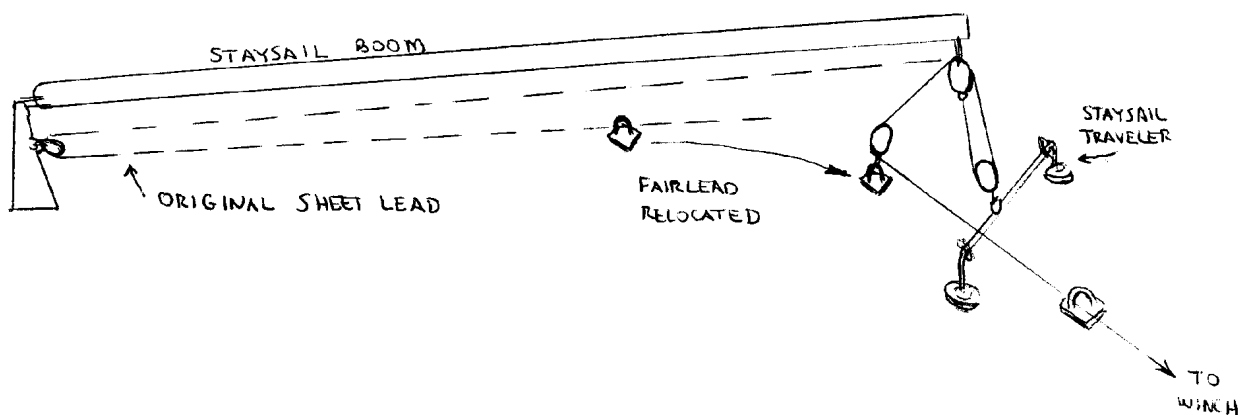
Erwin has rearranged his staysail sheeting as follows:

This arrangement has eliminated the compression load on the boom, and the loose sheets hanging up on the dorade vents (one owner lost a cowl vent this way). Incidentally, if anyone has replaced his staysail traveler with a better one, I'd like to hear about it.

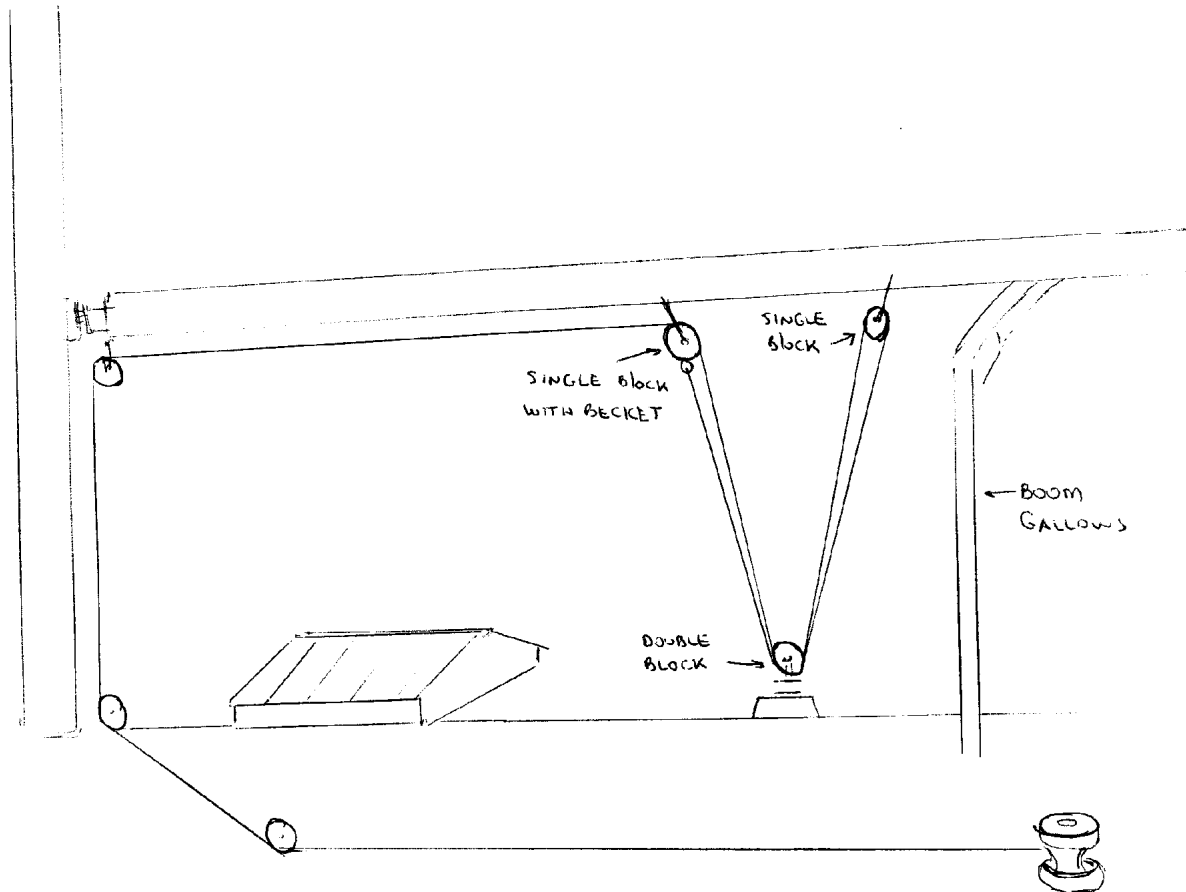
Erwin also re-rigged his mainsheet as shown to obtain a better load distribution.
